Modified Andersen and Modified ICOLD (DOISP-2) Methods of Risk Score for Dams in West Region of Indonesia

Miki Riando¹ ✉ Suseno Darsono² and Hari Nugroho³

¹Post Graduate Student, Department of Civil Engineering, Diponegoro University, Indonesia

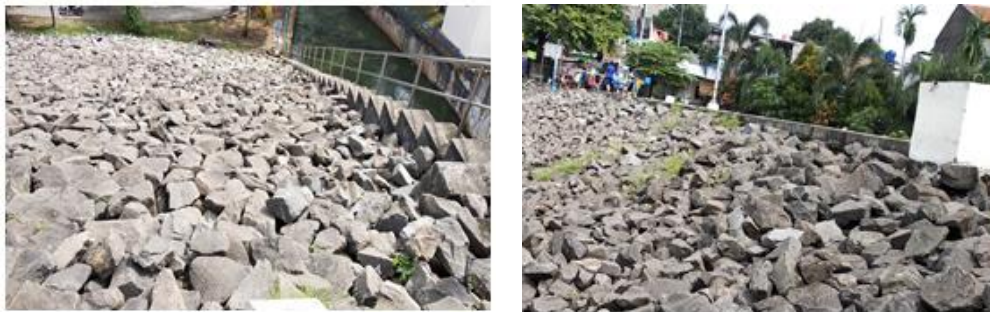
Mass movement problems during field inspections were encountered at the Gintung Dam, Cipancuh Dam, and Malahayu Dam. At the Gintung Dam, mass movement problems are found on the upstream and downstream slopes (**Figure 3**). This is due to the poor arrangement of the Riprap rocks, so the Riprap rocks found on the upstream and downstream slopes easily shift. Field inspection of the Cipancuh Dam in February 2009 found landslides and collapses along 30 m upstream and 50 m downstream, subsidence (**Figure 4**), and on the downstream slopes, there were deflections (**Figure 5**). During field inspections at the Malahayu Dam, the problems encountered were landslides on the cliff of the left pedestal hill (**Figure 6**), and on the upstream slope, there was a hole because the Riprap rock was taken by fishermen and used as a boat rest (**Figure 7**).

Figure 3 The upstream and downstream slopes of the Gintung Dam have decreased

If the avalanche material is not immediately cleaned up, it is feared that when large runoff discharges, the water flow in the chute passes over the top of the chute channel wall and erodes the cliff behind the wall, thereby increasing the problem of slope stability on the chute behind the chute channel wall. Handling the problem of slope stability, in this case, can use shotcretes.

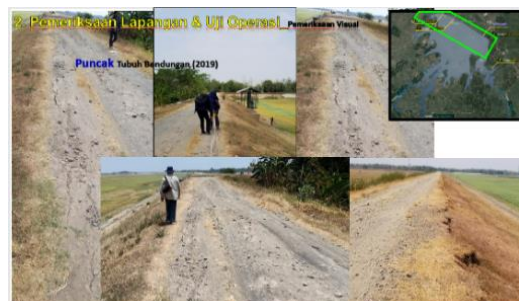
Figure 4 shows the condition of the top of the Cipancuh dam, which experienced an avalanche.

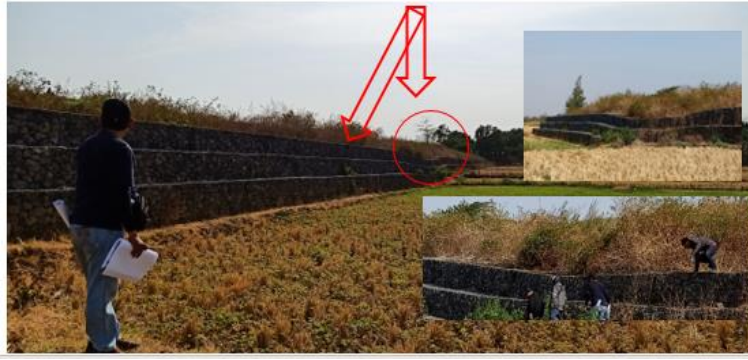
Figure 5 The downstream slope of the Cipancuh Dam, which is experiencing deflection

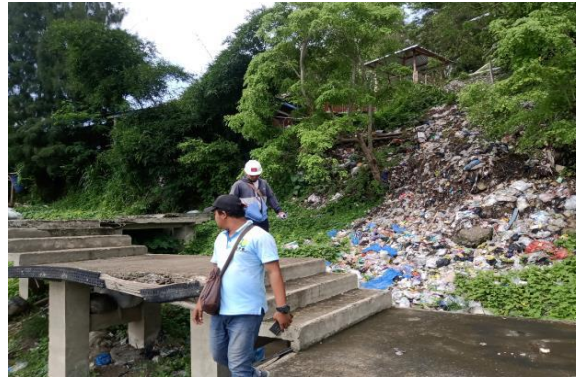
Figure 6 Landslide on the cliff of the left pedestal of the Malahayu Dam

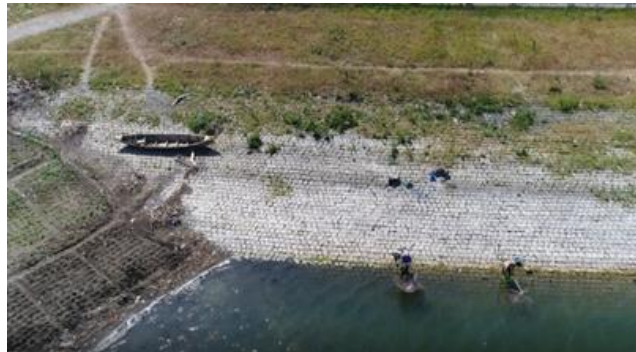
Figure 7 The Upper Slope has a hole because the rip-rap rock was taken by fishermen (Malahayu Dam).

5	Malahayu	There was a leak on the slope of the V-Notch canal caused by piles of garbage in the canal, there was an avalanche on the cliff of the pedestal hill, and there was a hole on the upstream slope due to rip-rap rocks that were not neatly arranged and taken by local residents.
6	Setu Patok	There is a need for pavement at the top of the dam, regular grass cleaning to prevent avalanches, leveling of the downstream slopes of the dam, especially in areas that are inflated and regular observations.
